NASA/TM-1999-209684

Evaluation of Pressurization Fatigue Life of 1441 Al-Li Fuselage Panel

R. Keith Bird and Dennis L. Dicus Langley Research Center, Hampton, Virginia

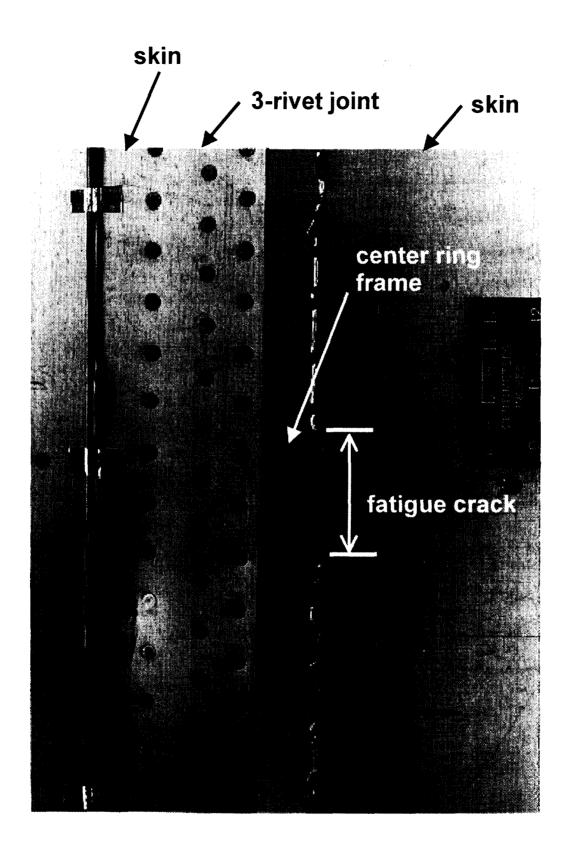
The pressurization test was interrupted periodically to visually examine the riveted joints in each panel for fatigue cracking. No signs of cracking within the joints were detected by inspections of the exterior of the panels. However, after 193,000 pressurization cycles, one of the panels failed catastrophically along one of the riveted splice joints. Figures 14 and 15 show an exterior view and an interior view, respectively, of the panel after rupture. The fracture occurred in the riveted joint with three rows of rivets. An examination of the panel fracture surface was conducted. Two distinct fatigue cracks were identified, each being approximately 2 inches long. The locations of these fatigue cracks are shown in figure 15. Figure 16 shows a detailed view of one of the fatigue cracks. The fatigue cracks initiated and propagated in the 1441 Al-Li skin along a rivet line hidden from view in the overlap joint, and would only have been detected by dismounting the panels and inspecting the interior of the panels. Thus, the cracks were not observed until fracture occurred. During the panel rupture process, the three ring frames were fractured by overload and the stiffeners buckled. The other panel remained intact, but examination revealed the existence of small fatigue cracks, less than one inch in length, in the riveted joints. These cracks were located in areas similar to the crack locations in the ruptured panel.

Figure 15: Ruptured fuselage panel (interior view).
